**From:** Monica Weil [mweil@ayoubengineering.com]  
**Sent:** Thursday, June 12, 2008 2:10 PM  
**To:** Andrea Ristine  
**Subject:** Exxonmobil, 44 Great Road  
**Attachments:** 3667 ACTON PICS.doc

EXXONMOBIL  
44 GREAT ROAD  
ACTON, MA

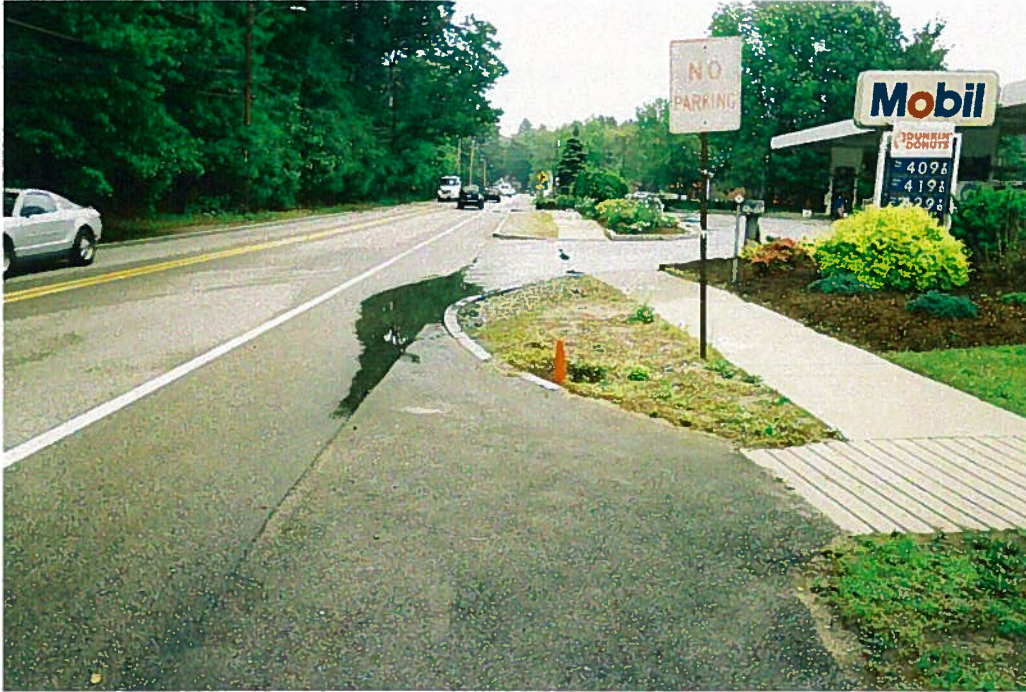
PONDING NEAR PILLAR HOUSE CONDOMINIUMS DRIVEWAY

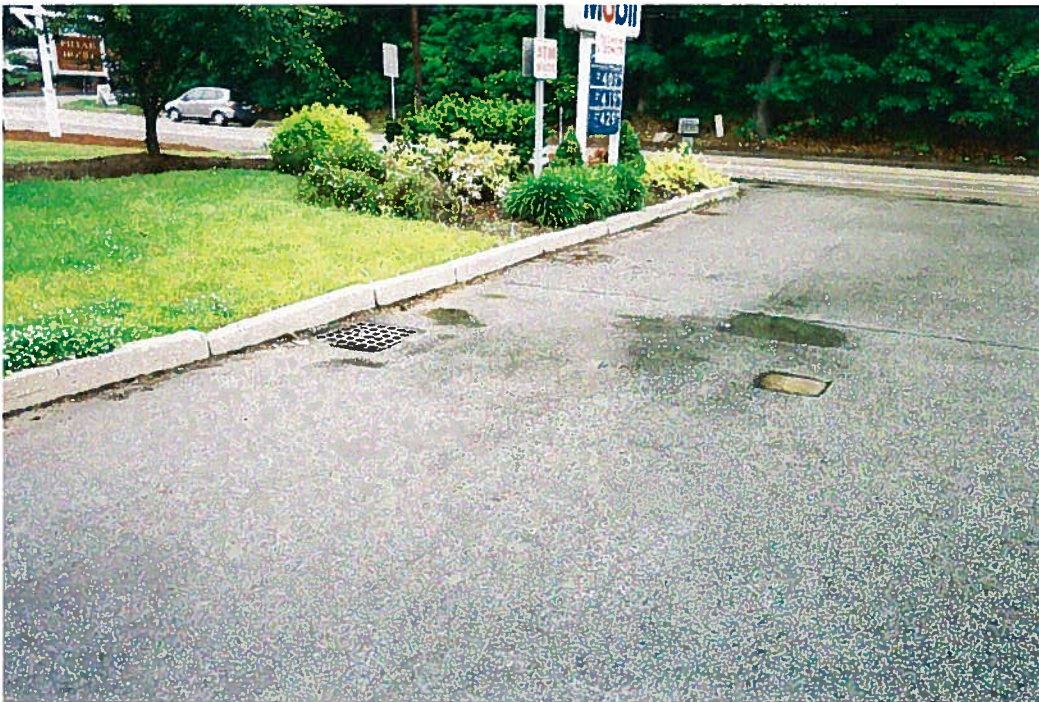
NORTHERN CATCH BASIN BY PILLAR HOUSE CONDOMINIUMS

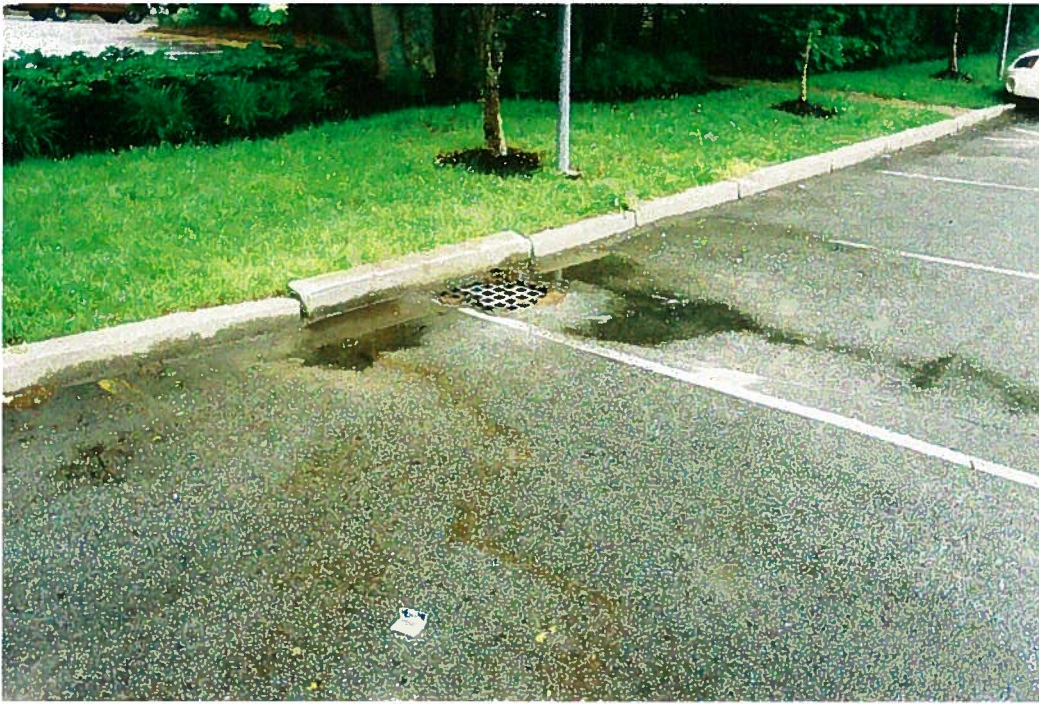
The Mobil site storm system does appear to be functioning properly with no ponding occurring. We checked every possible plan source and did not find any definitive plan showing the discharge point for the catch basin on the other side of the site. We believe that both catch basins on site discharge to leaching areas in the landscape beds.

EASTERN CATCH BASIN

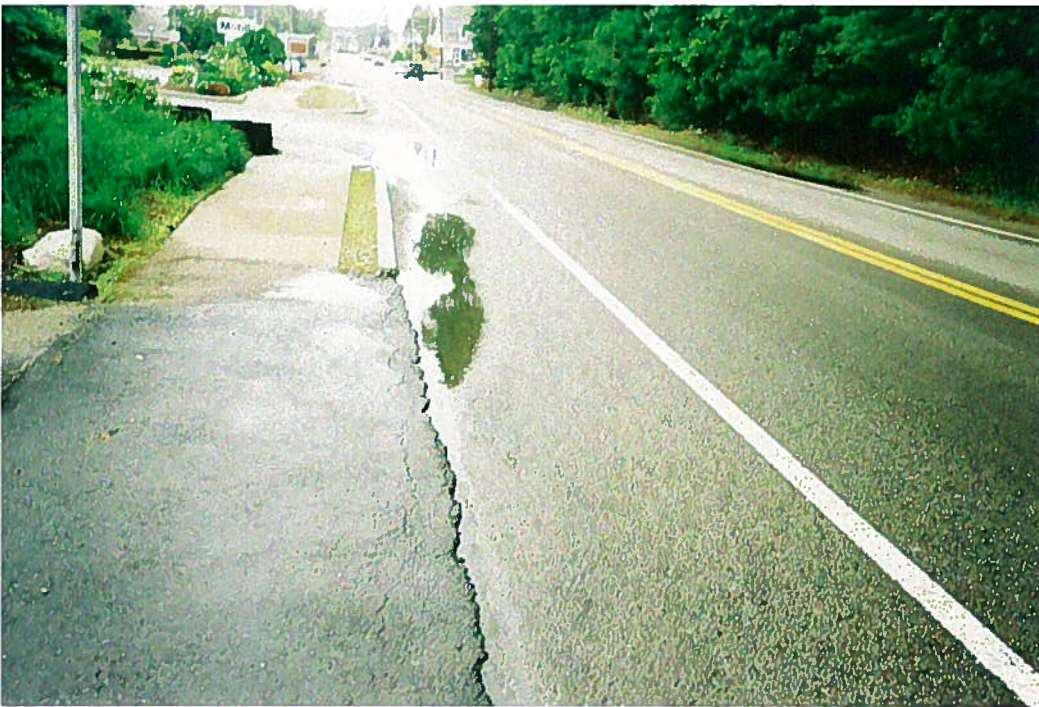
We did inspect the drainage and site conditions when it was raining and it appears that the cause of the limited ponding that occurs in Great Road is the very flat gutter grades in Great Road and the way the individual site driveways are raised to maintain runoff on the individual sites.

I've attached pictures showing how Great Road ponds and that clearly the Mobil site is at a higher elevation to maintain its own runoff and does not contribute to the ponding issue. There is no solution relating to the Mobil site that could help remedy this problem.

GREAT ROAD - PONDING DUE TO FLAT GUTTER GRADE
